Protein purification troubleshooting guide

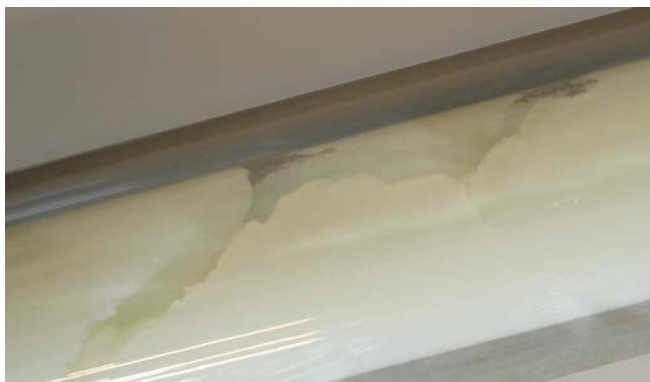
Air in the column

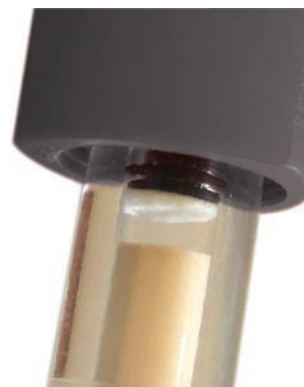
Compressed bed

Possible cause	Remedy
Bed compressed	<ul style="list-style-type: none"> • Clean column according to cleaning procedures and/or change filter • Check sample preparation. If sample is too viscous, back pressure will be high. Dilute sample or reduce flow rate • Repack column, pack new column, or use prepacked column
Microbial growth has occurred in column	<ul style="list-style-type: none"> • Clean column using recommended methods • Prepare and use predefined column and system maintenance methods. Make it a habit to include these methods in a method queue • Always filter samples and buffers. Choose low protein binding membranes such as Whatman™ regenerated cellulose • Store in presence of 20% ethanol when not in use
Clogged end-piece, adapter, or tubing	<ul style="list-style-type: none"> • Remove and clean or replace if possible
Outlet closed or pumps not working	<ul style="list-style-type: none"> • Ensure that column outlet is open • Check pumps for signs of leakage. If using a peristaltic pump, also check tubing
